Denver Interstate 70 Bridge Repair: Giving an Old Viaduct More Years of Life

How the life of a 1.2-mile-long viaduct in Colorado is being extended, turning a \$800 million replacement project into a \$21.6 million repair project

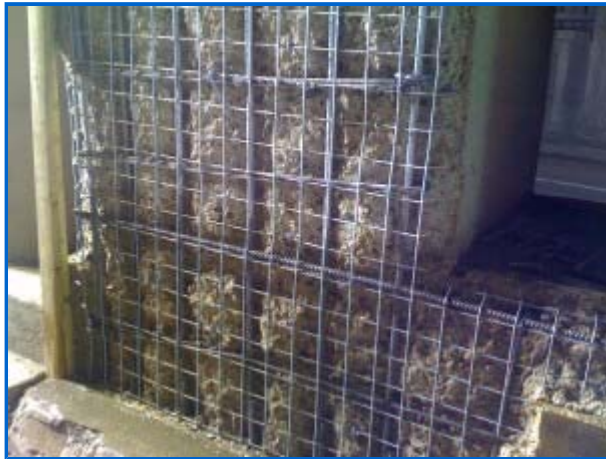
ACC workers replace the reinforcing steel with galvanized wire mesh to add structural reinforcement to the concrete.

wire mesh to add structural reinforcement to the concrete, wet the surface, and then we start applying the repair material,” explained ACC Assistant Project Manager Jimmy Jones. CDOT requires that the rebar be encased in concrete within seven days after it is replaced. Two crews of 12 to 15 men are working to make the repairs using seven manlifts, four all-terrain scissor lifts, 20-25 jackhammers and other hand tools.

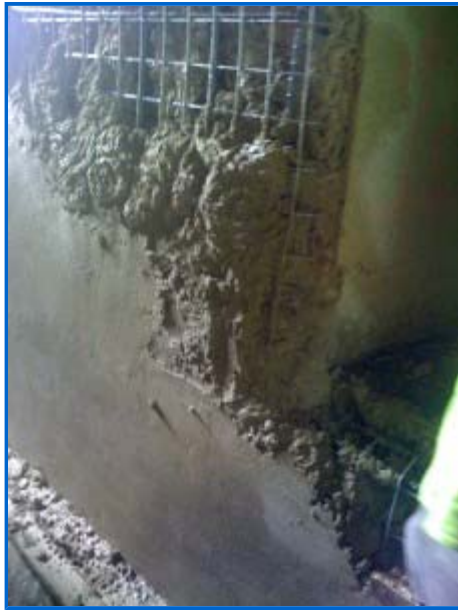
The depth of removed concrete cannot be greater than 6 inches, but these sections can be as wide as 8 feet.

ACC workers begin by inspecting the bridge's substructure to determine where concrete is damaged and needs to be replaced. Then they jackhammer out the pieces of deteriorated concrete and rebar, continuing until they reach sound concrete. Concrete removal is the most time consuming part of the job. The exposed, undamaged concrete is then sandblasted to create a rough surface for good adhesion of the repair material. The depth of removed concrete cannot be greater than 6 inches, but these sections can be as wide as 8 feet.

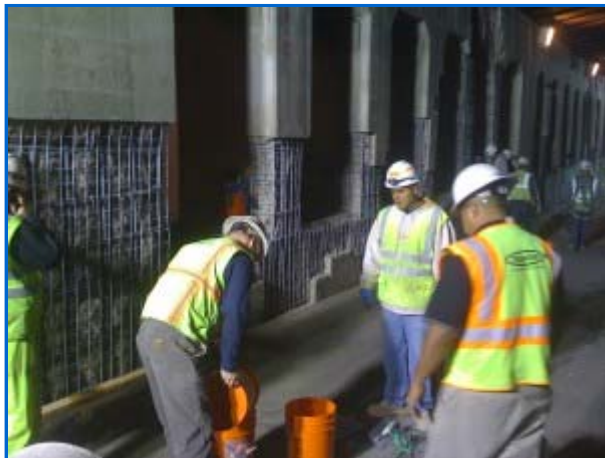
Completing the job will take about 6,000 55-pound bags of product, which are being used at the rate of roughly 50 bags per night.

Rapid Set Mortar Mix is being used for repairing all horizontal and vertical overhead areas covering 5,500 square feet of the substructure of the entire bridge. Rapid Set Mortar Mix is engineered for vertical and overhead up to 6 inches in depth in one application. Completing the job will take about 6,000 55-pound bags of product, which are being used at the rate of roughly 50 bags per night.

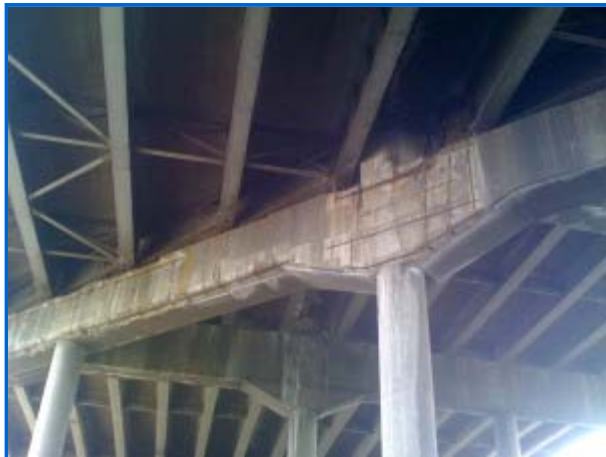
The I-70 bridge’s 60 expansion joints have been corroded by water and salt, resulting in deterioration of the reinforcing steel and the concrete surrounding that steel.

This bridge between State Highway 265 (Brighton Boulevard) and State Highway 2 (Colorado Boulevard) is one of 46 bridges in the metro Denver area said to be in imminent need of repair by the Colorado Department of Transportation (CDOT). Its 60 expansion joints have been corroded by water and salt, resulting in deterioration of the reinforcing steel and the concrete surrounding that steel.
